REPORT ON THE CAPSIZE OF THE PASSENGER VESSEL LADY D

FINAL REPORT

26 July 2004

John J. McMullen Associates, Inc.
4300 King Street, Suite 400
Alexandria, Virginia 22302

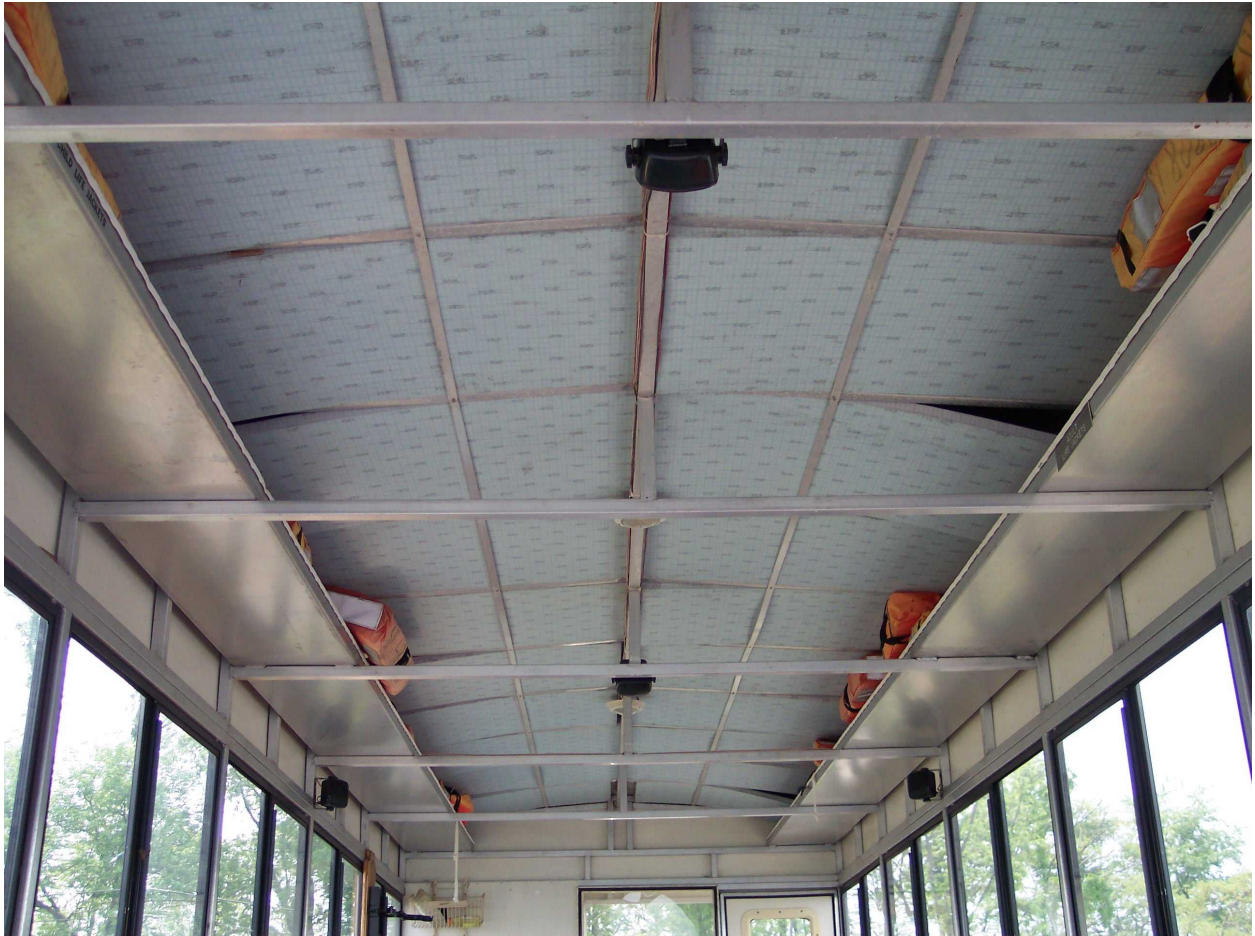
Figure 5 Interior of MISTY HARBOR Deckhouse Showing Canopy Construction

To be able to successfully complete the analysis described in the SOW, information about the vessel's weight, center of gravity, and wind profile were needed. Since the majority of the deckhouse of the LADY D was missing, assumptions were made about the size and weight of the deckhouse. These were made based on the data from the wreckage survey, the one passenger photo of the LADY D provided in Figure 4, and pictures of the MISTY HARBOR (data item #10) supplied by the boat builder. The deckhouse was constructed of 1.25-inch square aluminum tubing covered with thin (0.019-inch) aluminum sheet metal. Windows were either plate glass or Plexiglas. The survey of the vessel indicated that the deckhouse was 24'-1½" long and 7'-8" wide. It was estimated based on measurements of the partial aft bulkhead and the pictures of the MISTY HARBOR provided in Figure 5 that the height of the deckhouse at the sides is about 7'-0" and in the middle at the peak of the canopy it was 7'-6". The deckhouse has a peaked canopy, not a flat roof. Using the measurements of the vessel and unit weights of materials provided by the boat builder in Data Item #8, JJMA calculated the weight of the deckhouse as 975 pounds. The weight of the missing starboard bench was also calculated using measurements from the JJMA survey and data from the existing portside bench. The weight of the bench was calculated as about 92 pounds. These two pieces of data were be used along with the NTSB supplied passenger weight data, and the weight of the remaining hull to establish the total weight of the vessel at the time of her capsizing.

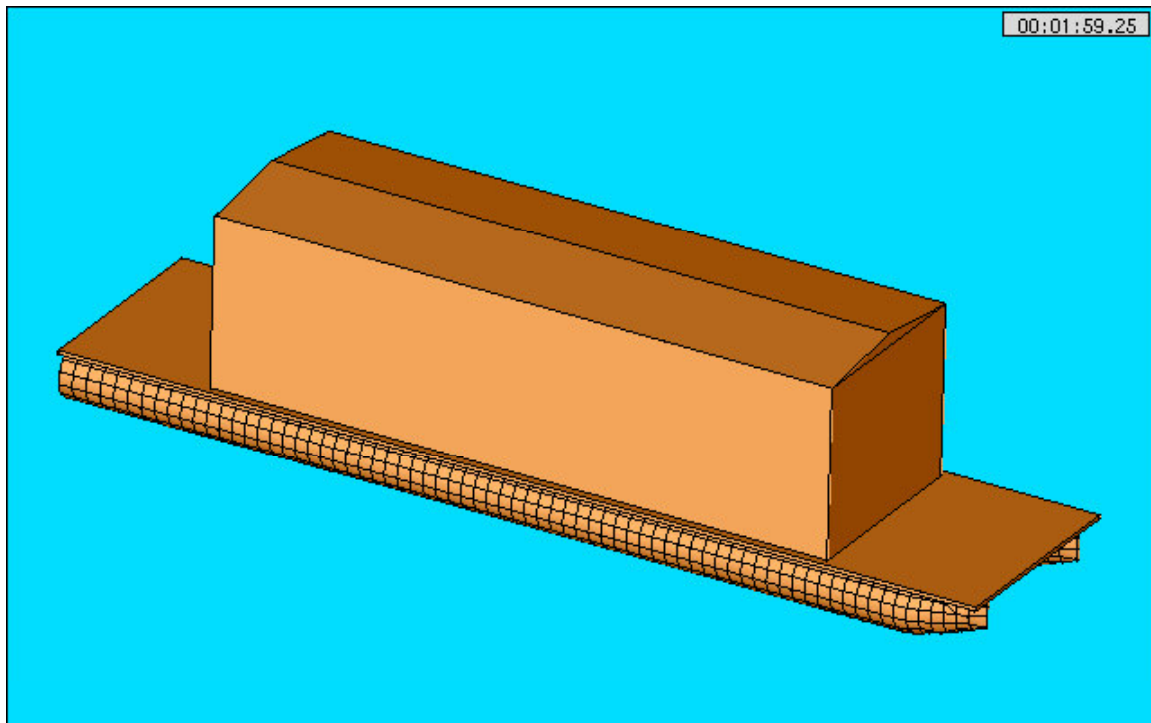
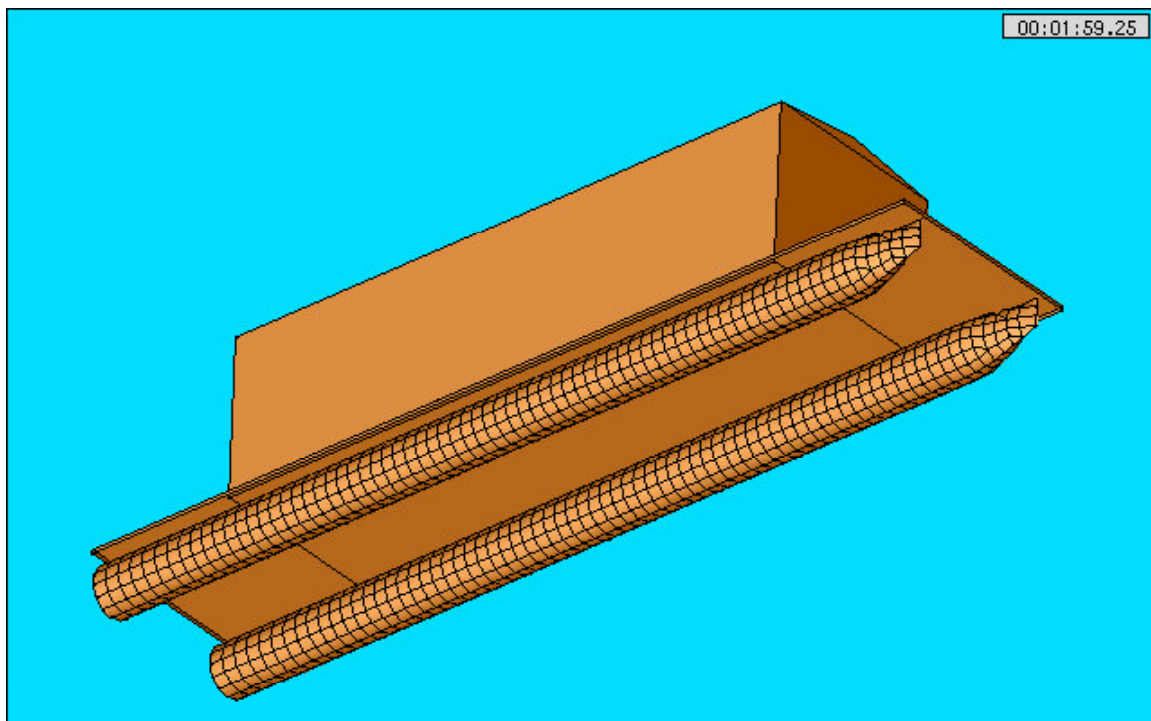
Figure 22 LADY D Panelized Geometry Model

The LADY D Model is composed of two basic components; the geometry and the mass properties. The model geometry was derived from sketches and an on-site survey of the vessel wreckage. The details and dimensions of the hulls, deck, superstructure and other features have been reported in Section 2.2 of this report. From this information a 3D panelized model, illustrated in Figure 22, was prepared for the simulation.

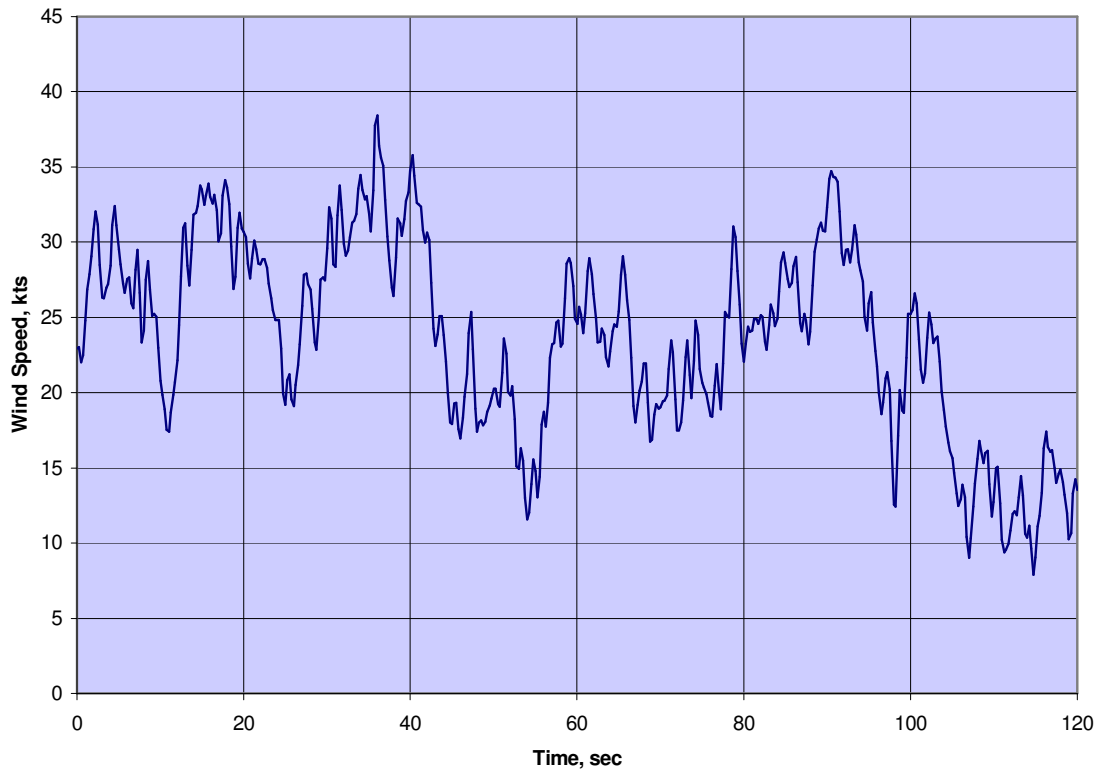
Figure 25 Sample Wind Speed Time Series

In order to perform the simulations for the dynamic analysis, the steady wind speed and gust speed had to be converted into a time series. The time series represents the wind speed at any given time and tells the simulation what the wind speed is at each time step as the simulation progresses. A sample of the wind speed time series used in the simulations is shown in Figure 25.

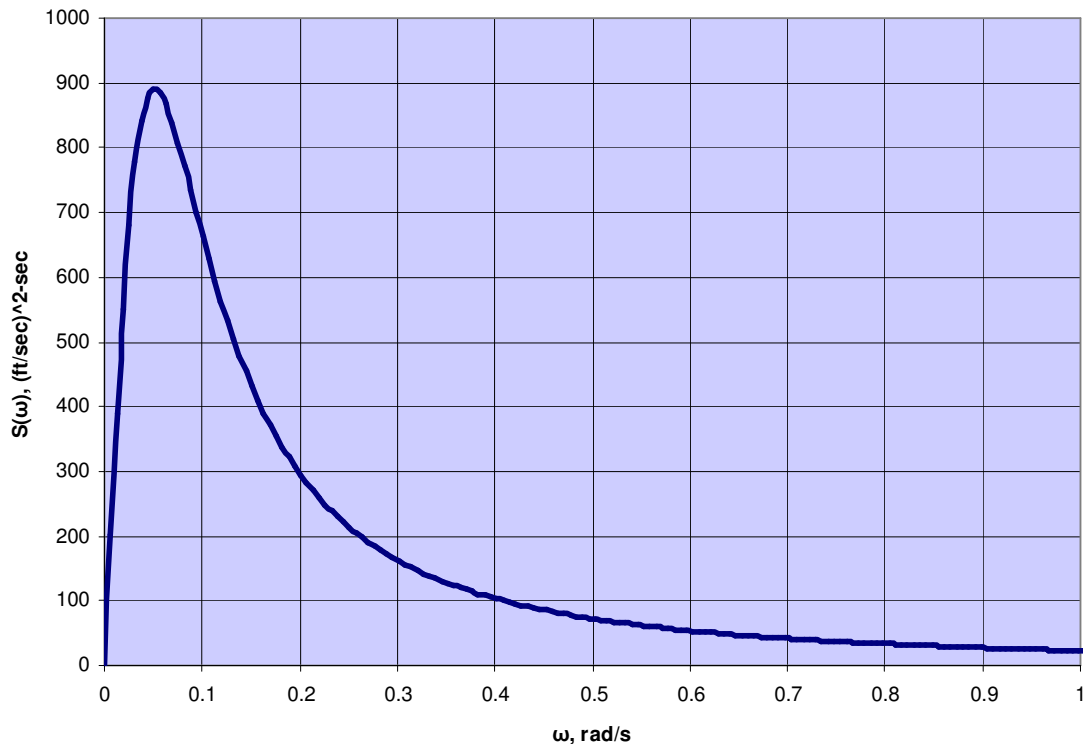
Figure 26 Davenport Gust Spectrum Estimate at Capsizing Site at 1600 EST

In our case, the mean wind speed, V_{wind} , measured at BMC at 1600 EST is 42.2 ft/sec (25 knots) and $C_D = 0.02$ is most appropriate for Northwest Harbor, a waterway with surrounding buildings. $C_D = 0.005$ is used for large expanses of open water and $C_D = 0.05$ is used to calculate gusts between buildings on city streets. The resulting gust spectrum is shown in Figure 26.

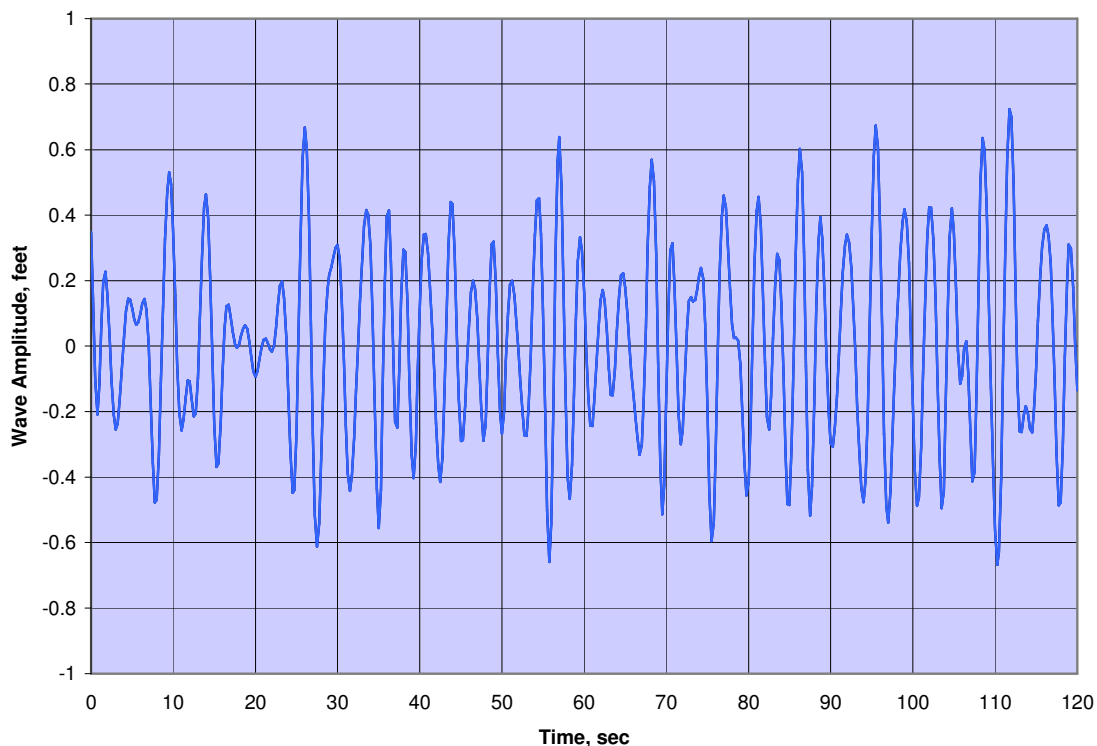
Figure 27 Sample Wave Amplitude Time Series

In order to perform the simulations for the dynamic analysis, the estimated wave condition had to be converted into a time series. The time series represents the wave speed at any given time and tells the simulation what the height is at each time step as the simulation progresses. Part of a time series used in the simulations is shown in Figure 27.

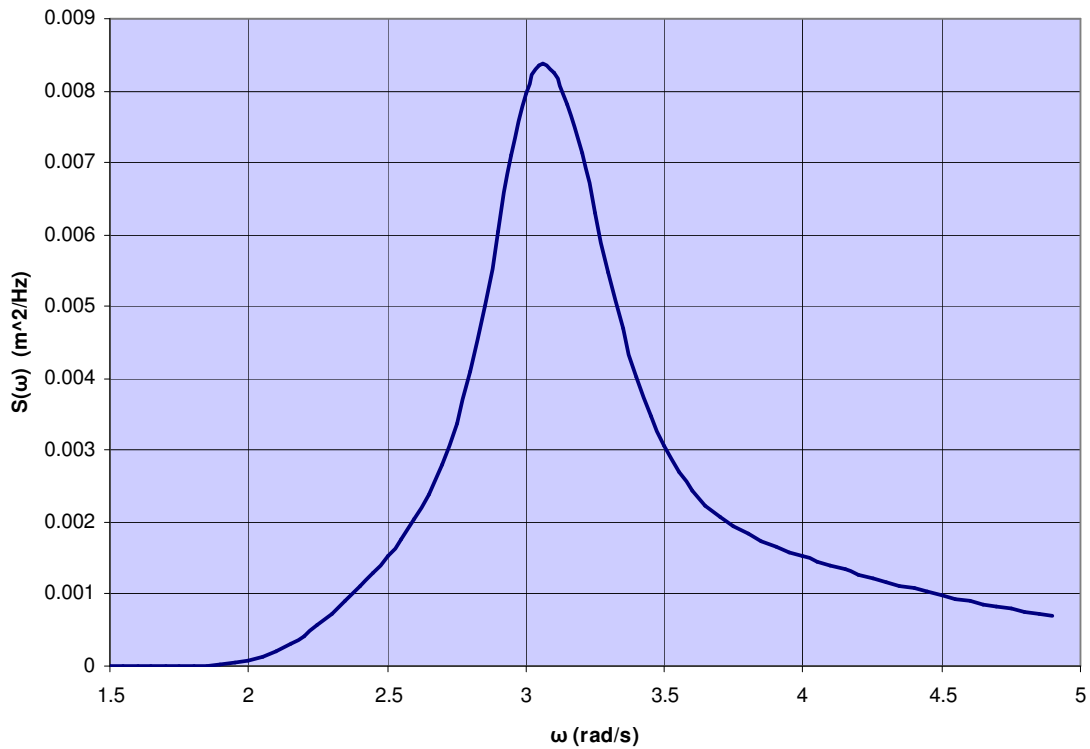
Figure 28 JONSWAP Wave Spectrum for 25 kts Wind and 1.5 nautical miles Fetch.

So in order to develop the theoretical JONSWAP for the conditions at the time of the capsizing, fetch and steady wind speed must be known. As previously discussed, steady wind speed was 25 knots. Fetch, as shown in Figure 20, was between 1 and 1.5 nautical miles depending on variations in the wind direction. For the JONSWAP calculation, a fetch of 1.5 nautical miles was used. When these equations are exercised for the conditions of 25 knots steady wind speed and 1.5 nautical mile fetch, the spectrum shown in Figure 28 results.

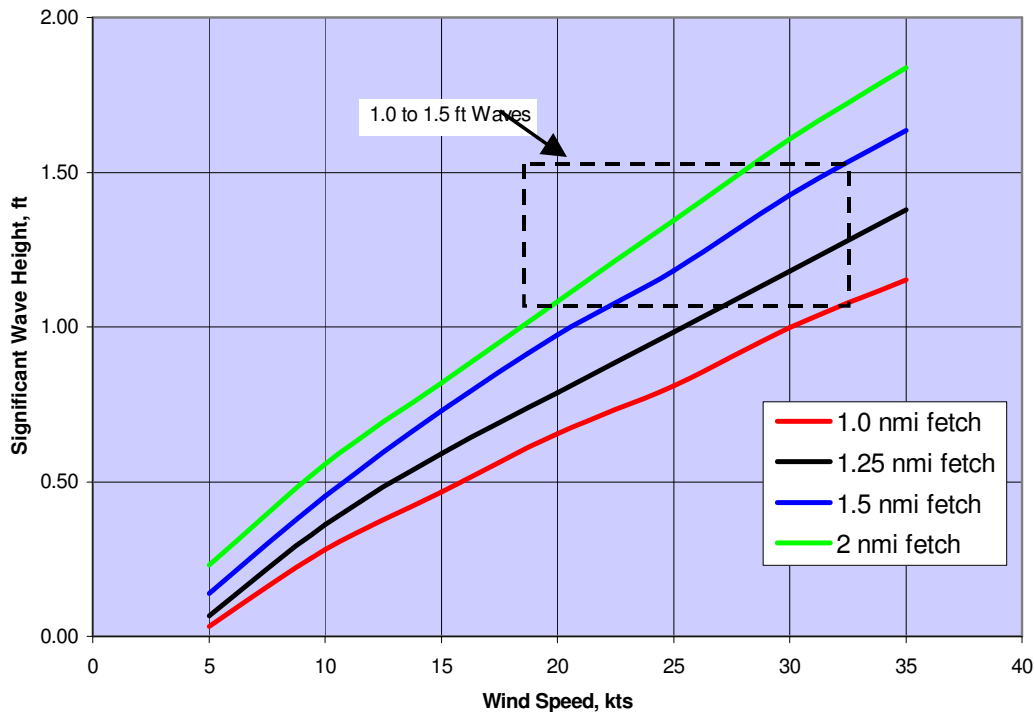
Figure 29 JONSWAP Wave Height Development

Based on the JONSWAP Wave Spectrum the significant wave height that results from exposure of the inner harbor to 25-knot winds over a 1.5 nautical mile fetch is 1.25 feet. The peak period is 3.0 seconds. For perspective, JONSWAP wave heights developed for wind speeds from 5 to 35 knots over fetches of from 1 to 2 nautical miles are shown in Figure 29. This figure shows that the reported wind speeds produce waves of 1 to 1.5 feet when blowing over the northwest harbor

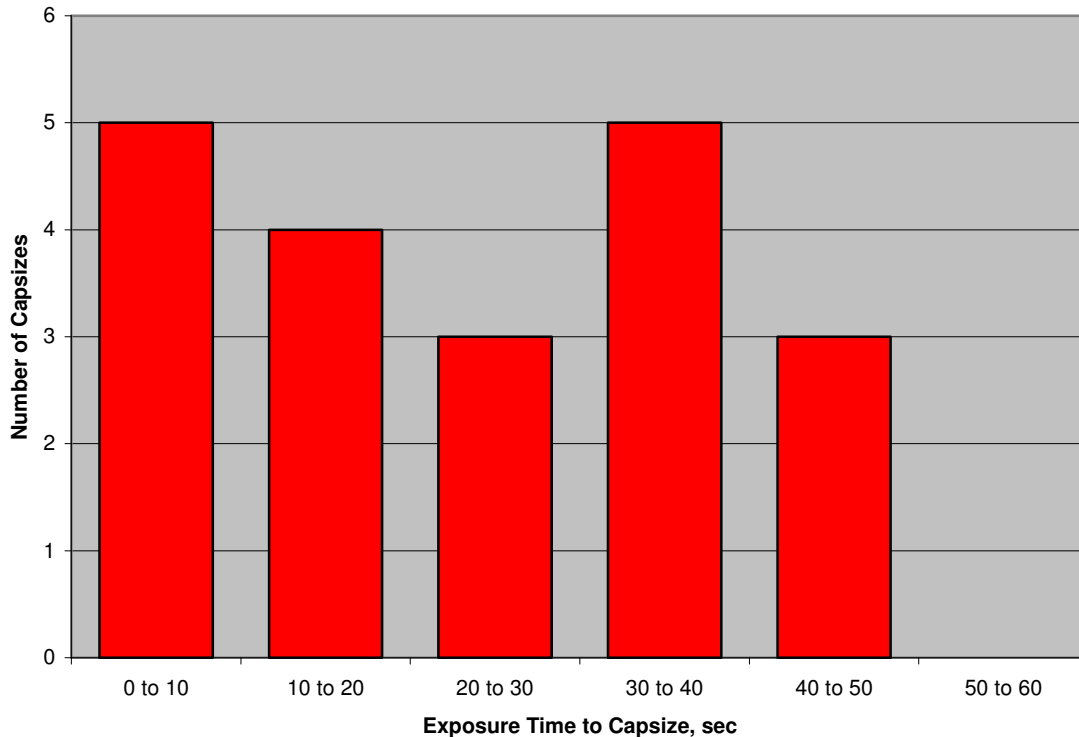
Figure 35 Exposure Time to Capsize Histogram

Twenty simulation runs should be sufficient to expose any trends or relationships between wind, wave and time to capsize. More simulation runs would increase the statistical confidence in the results, but may or may not reveal trends or relationships. A histogram showing how many simulated capsizes occurred between 0 and 10 seconds, 10 and 20 seconds, etc. is shown in Figure 35. The histogram does not show a trend. Absence of a trend indicates that any exposure duration to wind and waves from the port beam could result in capsize.

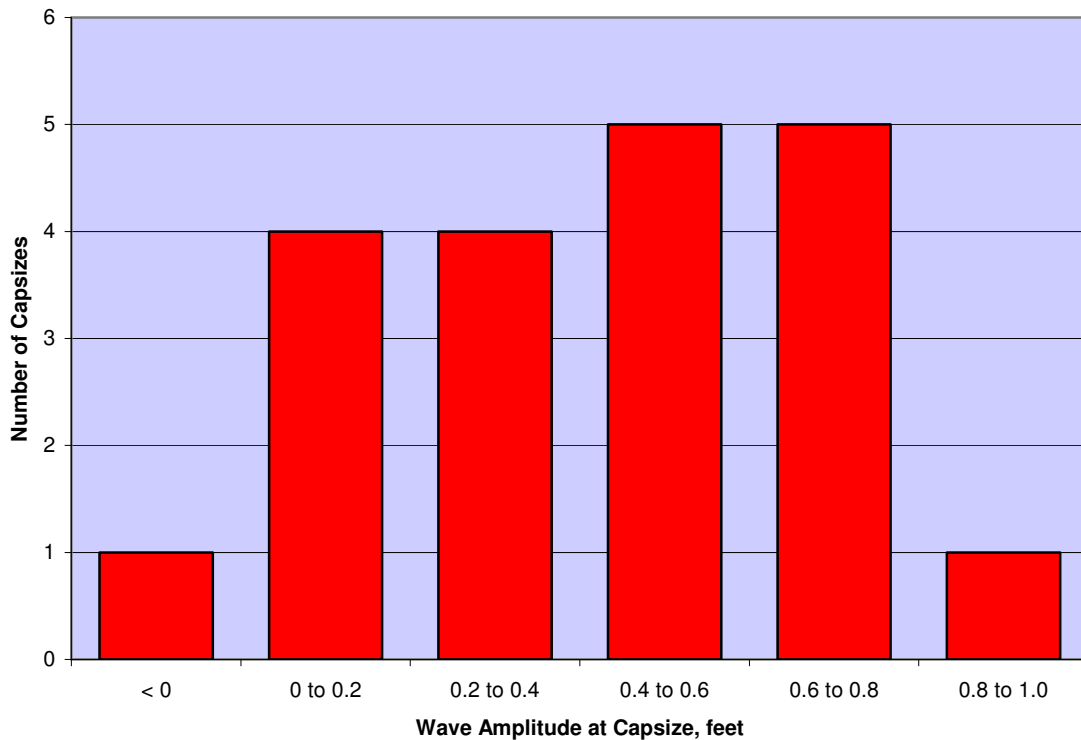
Figure 36 Wave Amplitude Histogram

A histogram of the number of capsizes that were simulated at various wave amplitude bands is shown in Figure 36. The wave amplitudes shown those at LADY D at the time of capsize. Jonswap waves of 1.25 feet significant wave height and 3.0 second period were input to the simulation. The average amplitude of this wave is 0.4 feet. The relationship between significant wave height and average wave amplitude is:

1.0 foot band is due to the fact that higher waves occur less often. The wave simulation time series can be reviewed in Appendix E.

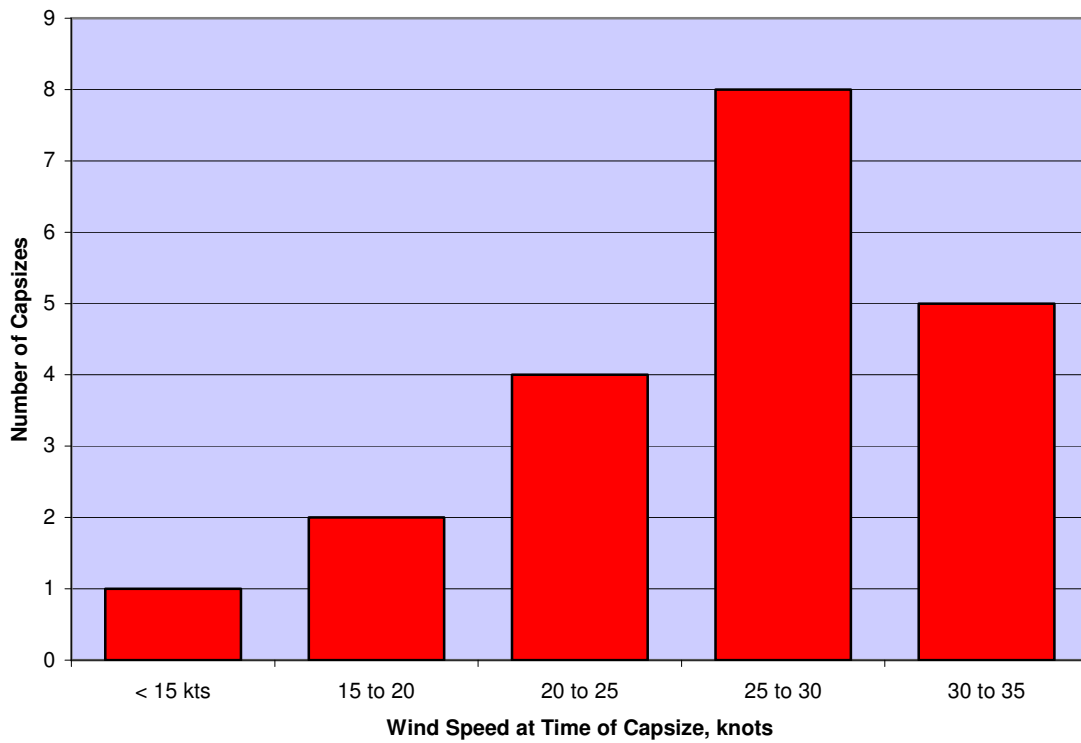
Figure 37 Wind Speed Histogram

A histogram of the number of capsizes that were simulated at various wind speed bands is shown in Figure 37. The wind speeds are those at the time of capsize. The simulated steady wind speed was 24 knots with gusts to 42 knots. Based on the twenty simulations, wind speeds below 24 knots could cause capsize. Fourteen cases had wind speeds above 24 knots at the time of capsize. With the exception of Case #20, the maximum gust over the duration of the simulation did not occur at the instant of capsize. The wind simulation time series can be reviewed in Appendix E.
